Pipeline Worldwide – Impact Report

Project Name: Rehabilitation Of Moyo General Hospital Water Transmission System

Project Location (Village/Sub- County): Medical Quarters Village, Elenderea Parish, Moyo Town Council

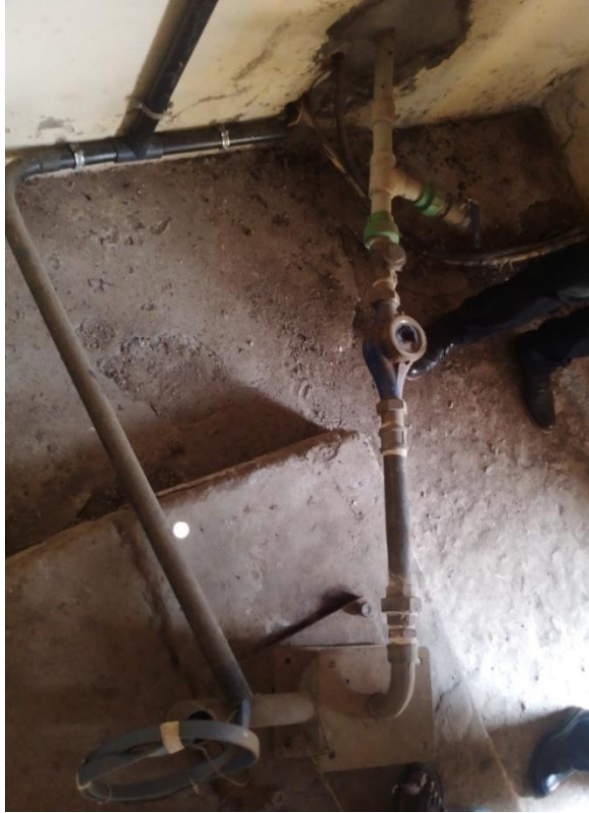
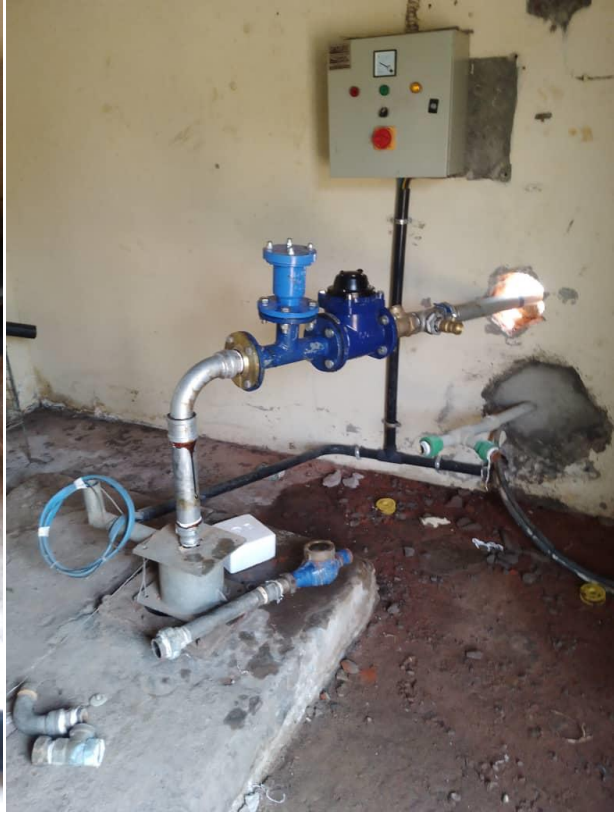
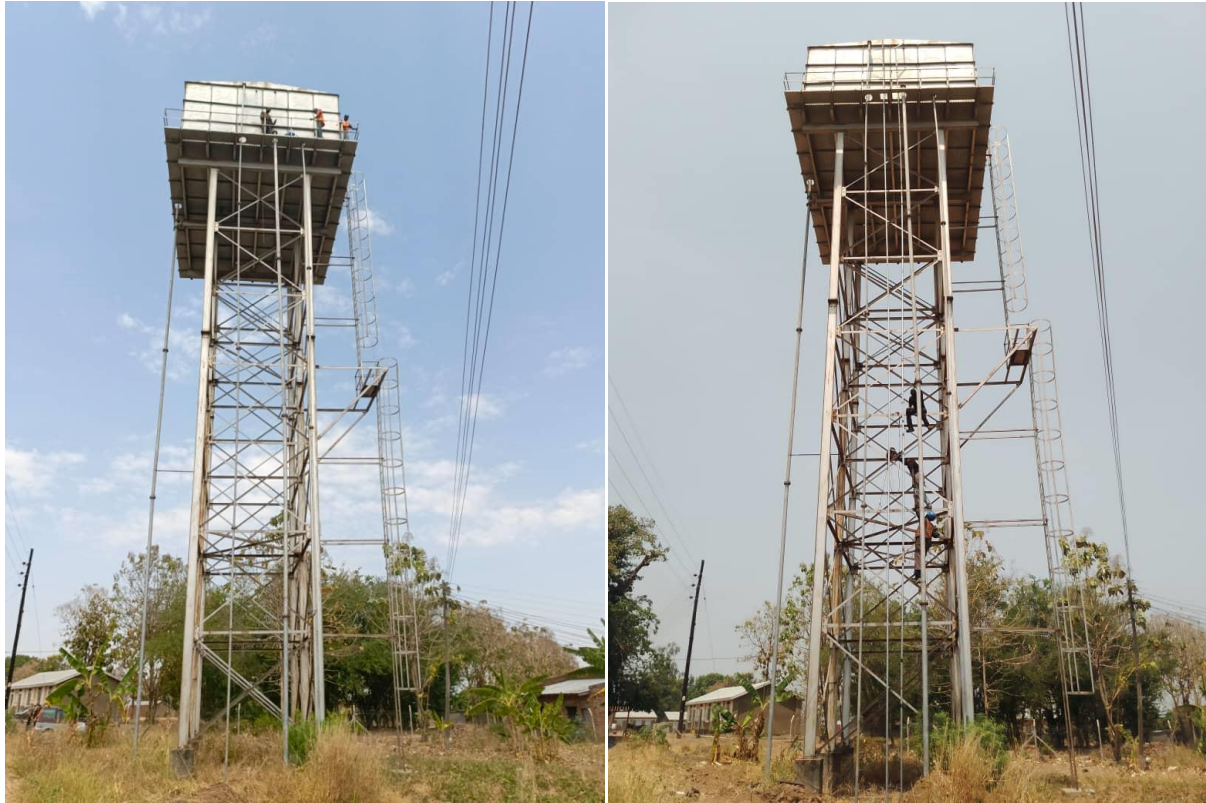
Photos 8: Riser pipes before and after connections to the tank

1. Replacement of BH4 Transmission line to 75mm to 63mm, including fittings and excavation plus protection at road crossings through using sleeves made of galvanized iron pipes.
2. Independent Transmission line for BH2 - HDPE Pipe 40mm including fittings
3. Riser Pipe-GI BH4 63mm including its fittings.
4. Riser Pipe-GI BH2 40mm including its fittings.
5. Supply and installation BH1 Pump Complete.
6. Restore connection of BH 2 including deeper excavation, protection of cables through galvanized iron pipe sleeves, water proof joints and marker for future safety.
7. Restore connection of BH 1 including deeper excavation, protection of cables through galvanized iron pipe sleeves, water proof joints and marker for future safety.
